Q&A FOR YOUR CATALINA THAT'S BEEN FACTORY APPROVED

Catalina 470

A Heated Issue

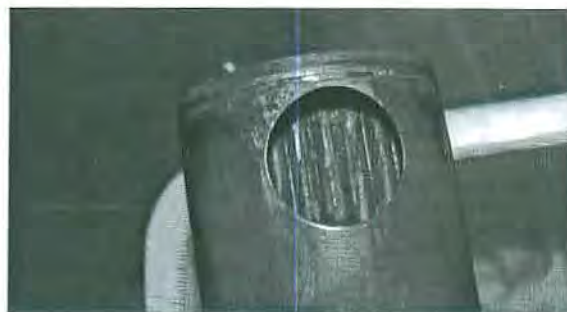
allowed to work. The effluent coming out of the exhaust when the engine was restarted showed no appreciable material. That part of the problem was eliminated. The fresh water side of the system was then checked. The anti-freeze mixture, per Yanmar specs, was checked and it was spot-on. Quantity was correct and no leaks in the system were found. All fittings were clean, dry and tight. By process of elimination we arrived at the heat exchanger. The first photograph shows what we found when the heat exchanger bundle was removed. The material is a blackish-brown, sticky, oily goo!! As you can tell by photo (1), the tubes were heavily covered with it on the discharge end of the tube bundle.

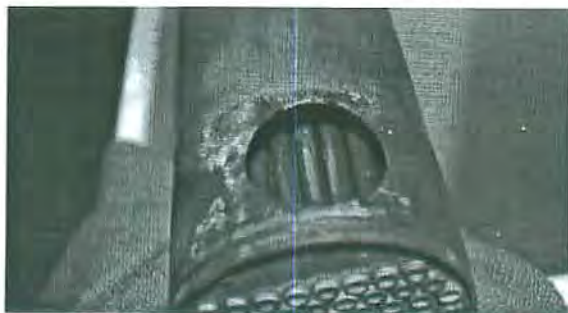
The inlet end, shown in photo (2), was more lightly covered. The white area on the tube bundle (second photo) is where I rubbed the material off with my finger.

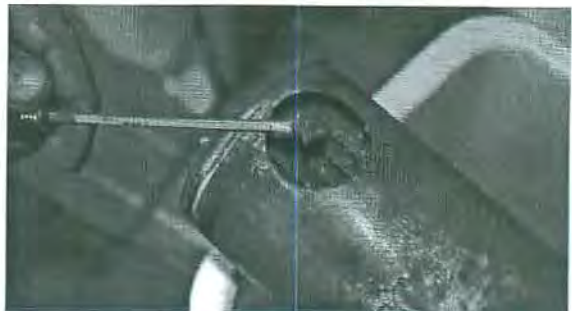
Photo (3) shows the goo on the end of a screwdriver after I gently scraped some out from between the tubes.

Needless to say, with this amount of material preventing contact of the two coolants the ability of the heat exchanger to exchange heat was greatly restricted. We had found the problem. How to clean this unknown material out of the heat exchanger bundle was the next hurdle while we attempted to find out what the material is and where it came from. My engine shop, Marine Engines Unlimited of Galesville, MD and its owner, Don Hardy were of great assistance in narrowing down the problem and then in
