Q&A FOR YOUR CATALINA THAT'S BEEN FACTORY APPROVED

Catalina 470

Windlass Surprises & Underwater Lights

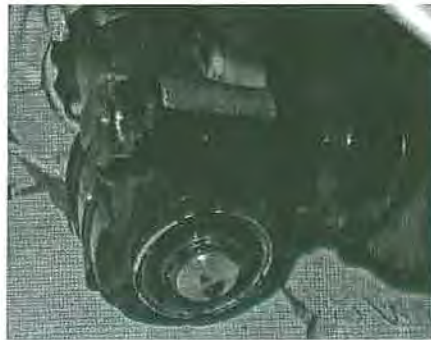
oil running down the aft side of the crush bulkhead. The only oil running thru that area "should" be from the bow thruster and getting it up as high as he had seen it was not possible. He removed the cabinet from the forward bulkhead of the forward shower and VOILA! The drive motor of the Maxwell 1200 windlass drives a shaft with a wormgear. This gear engages a gear wheel on the base of the vertical shaft which turns the windlass drum thru the clutch cones. What Larry found was that one of the four bolts which holds the wormbox of the windlass onto the spacer tube had come completely out of the wormbox and the other three bolts were very loose. As a result, the worm drive was not engaging the wormwheel and although the electric motor was spinning on command, it had nothing to drive! The oil he found on the crush bulkhead was from the worm-drive housing. It is interesting to note that Maxwell had previously informed me that the wormdrive housing was NOT an Owner-serviceable part. We found that not to be correct. The first photo is of the re-assembled windlass. Note the holes (only three can be seen)

for the Allen-head bolts which hold the assembly together. Replacement bolts were found at the local ACE hardware store. They are metric.

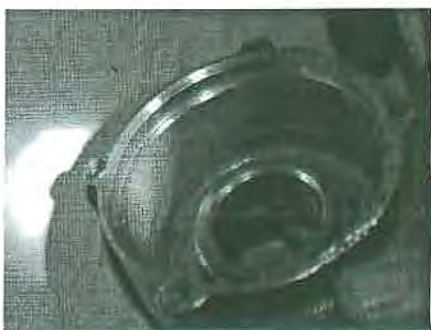
The second photo shows the empty lower wormbox. Here, all four bolt holes are visible.

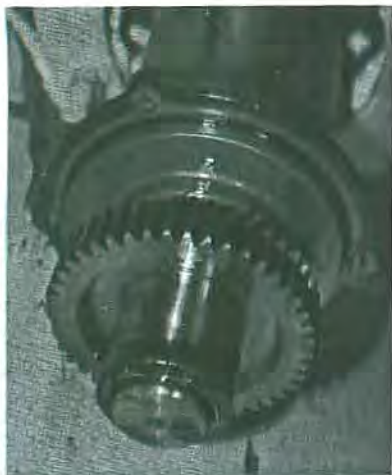
The last photo is the wormwheel itself which turns the windlass shaft/drum. Note that the wormgear housing/wormgear has no port or opening for servicing the oil level. The oil level is viewable thru a port on the end of the wormdrive.

This level should be checked regularly and the oil replaced every three years. Larry's windlass wormbox was filled with the required 90wt oil as we held it level near the wormgear housing. Then, using the new bolts, we pushed the wormbox up against the wormgear housing and seated it. There is an O-ring in the wormbox flange. When the two parts were seated together, the oil overflowed somewhat but the sight gauge showed full. Using a long Allen wrench, we tightened the bolts and the re-assembly was complete. Cleaning up the mess took only a few minutes and then it was time for the moment of truth...would it work??? When Larry's wife Wendy stepped on the foot switch directly above us, our efforts were rewarded with a fully-functioning windlass! The moral of the story: CHECK THE BOLTS THAT HOLD THE BOTTOM OF THE ASSEMBLY TO THE TOP!!! Also, you CAN service the drive section of the windlass; it is a bit messy but easily done. Check the oil level on the sight glass and, if it is down to less than half, get out your Allen wrench, 90 weight oil, a roll of paper towels, loosen the aforementioned bolts and slide the housing down them about 1/4 inch. Insert the end of the 90 weight oil tube between the upper and lower housings, squeeze and fill the lower housing. Push the halves back together, tighten the bolts (TIGHT!) and you are done. Pulling up your anchor by hand or cranking it up by using the emergency crank due to windlass failure because of lack of easy maintenance is not something we want to engage in.

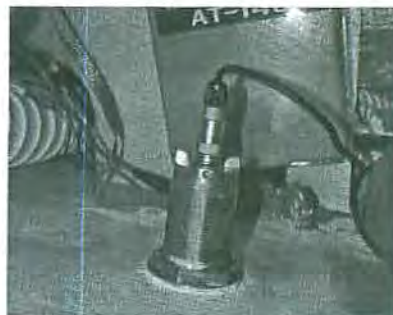
The boat was out of the water for about a week so the 5200 was dry when the boat was splashed. As you can imagine, I kept the lazarette cleared of everything when the boat was launched. There were no leaks. The next photo is of the completed installation inside the lazarette.

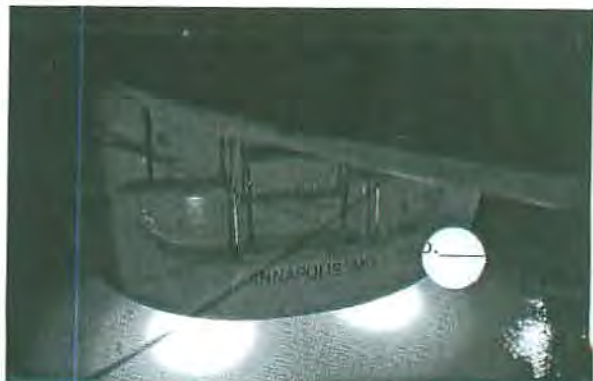
The last photo is of the lights in action here on the Chesapeake. Admittedly, they are not as bright as they will be in the clear Caribbean waters this winter. Still, they do add a nice touch to a fine boat!!
