Technical Pull-Out

Catalina 470 National Association

Windlass Downs & Ups

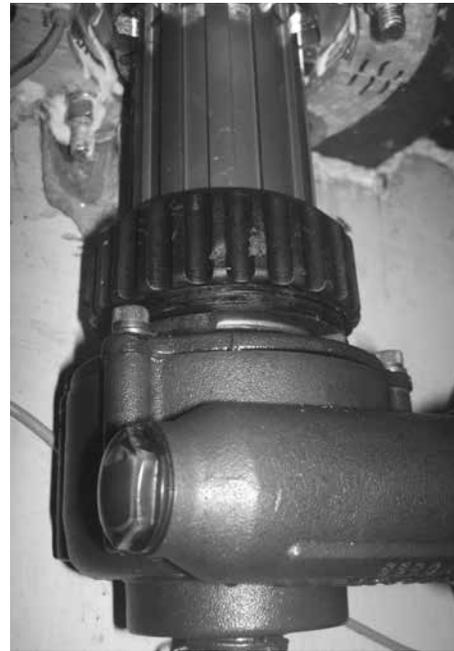
Under-deck components of Maxwell 1500 vertical windlass.

Somehow, these screws had loosened with use and this allowed the top and bottom sections of the transmission housing to shift slightly when loaded. It had gotten to the point where they could shift just enough to cause the vertical shaft gear to bind against the horizontal worm gear resulting in a very high load and current draw that would activate the breaker. The fix was quick and simple: tighten the four hex-socket screws (see photo).

Checking the windlass on a periodic basis (every couple of months) is now part of the maintenance schedule for *Onward*. Check: power connections for tightness and cleanliness; the four hex-socket screws on transmission unit for tightness; the knurled knob that connects the motor to windlass base for tightness; for any signs of seawater leaks around windlass base, mounting ring and bolts; for signs of transmission lubricant level and leakage. Note: it is worth learning how to get behind the washer/dryer or forward shower cabinet to get to the windlass for these periodic checks and service.
