# Tech Notes

## CATALINA 470 NATIONAL ASSOCIATION

### C470 Compression Post Access Hole

C470 Association  
Technical Editor  
Joe Rocchio

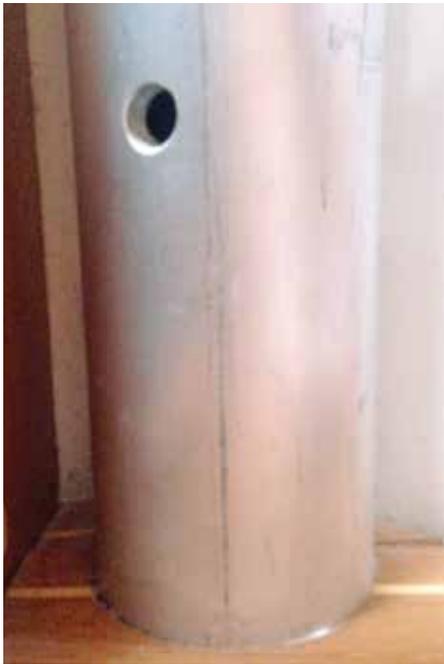
My friend's comment led me to consider breaking up the problem into segments. First step: I carefully and very slowly drilled a ~0.125" dia. test hole in the base of the compression post (see photo, ~7" above the deck and ~1" aft of the starboard vertical centerline). The wall thickness was about 0.75". In several stages, I slowly drilled out this hole (taking great care that the drill bit barely penetrated beyond the tube inner wall so as not to damage the cables inside) to a final ~1" diameter, large enough to allow a PL259 connector to go through.

Second step: I was able to run an electrical snake from the wire exit port in the bilge up into the base of the compression post. There I snagged the tip of the snake through the new access hole and attached a messenger line that I pulled back into bilge.

Third step: I went up on deck, and after many tries, was able to run the snake from the topping lift mast exit port down the mast, through the mast step, and into the compression post. I again used the access hole to snag the tip of the snake and attach the first messenger line. On retrieving the snake there was now a messenger line that went from the bilge to the lower part of the mast on deck.
