Catalina//
MAINSHEET

MAY 2006 • VOL 24 • NO 2

BOOM!

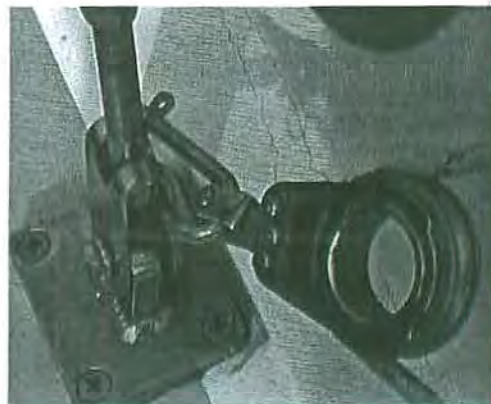
Aboard BECKONING... Hull # 76, the Dutchman boom brake is installed as shown in the photos. The control line, as recommended by the factory, is attached to the aft most chainplates with appropriately rated Wichard shackles and is professionally spliced to ensure maximum strength. The control line is routed from the starboard side chainplate to the brake then to the port side chainplate via a Garhauer block (shown) then to a rope clutch added to the existing cluster in the cockpit. The brake itself is mounted

(shown) to the underside of the boom with large screws (bedded with Tef-Gel) holding a tang in place. Again, an appropriately rated Wichard shackle is used between the brake and the tang. There can be a significant amount of strain on this equipment; using properly rated shackles, blocks and lines is mandatory!!

The boom brake is capable of being used as a preventer when running downwind for long periods of time and will hold the boom in place when encountering rough seas. It can also be used to hold the boom in place when an anchor and a guest wants to hang off the boom in a hanging chair (shown)! However, the primary use is to control
