Q&A FOR YOUR CATALINA THAT'S BEEN FACTORY APPROVED

Catalina 470

A Soda-Blasted Bottom Job

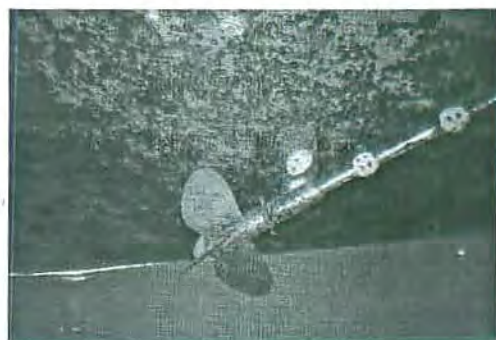
Beckoning hull after 3 weeks of not cleaning the hull in the BVI

photos show what the hull looked like at the end of a season of serious sailing in the waters of the USVI/BVI. This photo was taken by me in late April while on the anchor at Jost Van Dyke, BVI. The second photo is of the bottom of the keel looking up. The ACT paint had failed completely! In places, the ACT paint had fallen off the hull or showed cracks in the paint where it was ready to fall off if touched.

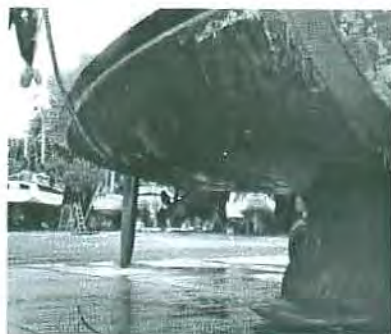
Beckoning hull half power washed upon haul out

arrived in Annapolis at the end of the first week of June. Of the five weeks from arrival in Annapolis to haulout for the bottom work, 4 weeks were spent off the dock sailing vigorously. The photos show the hull upon haul out.

Obviously, the bottom paint had failed in the Chesapeake also! The cause of this, given that this paint had always performed as advertised in the previous 6 years is unknown. One theory holds that the paint leached out in the Caribbean due to the much harsher environment. One can see in the photos that the standard power washing had removed some of the ACT paint. The remainder was to be removed by soda-blasting.

Soda blasting, according to the yard, uses compressed air and baking soda as a blasting medium to remove old paint from the hull. It is gentler on the fiberglass than using sand as the blasting medium or simply grinding off the old paint with a grinder and sandpaper disks. The cost, \$2000 for a C470, was deemed to be acceptable given that much of the paint which survived the pressure-washing was not removable by

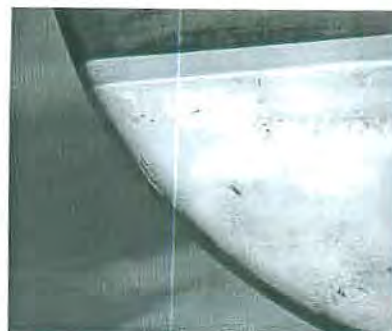
Beckoning bow after soda-blasting damage and vinylester patching

The photos show the numerous repairs, with a vinylester compound, which were required when the soda-blasting perforated the hull down to the fiberglass matting. There is no pattern to the perforations nor is there a reason for this much damage to the hull. The soda-blasting even removed a significant portion of the epoxy casing of the solid lead keel. All these perforations were eventually covered with the vinylester compound and smoothed out via sanding and buffing. The result was a hull of incredible smoothness which was ready for the new paint.

Beckoning splashed into the water about 2 weeks after haul out with a smooth bottom, two coats of Trinidad SR hard anti-fouling paint, a squeaky clean bow thruster cavity and prop, a standing rigging inspection (no problems on this 7 yr-old boat after a full season in the Caribbean) and the result has been the fastest speeds under power or sail that she has ever shown. The long-term effects on the hull of the vinylester repairs have yet to be determined. The boat has now been sitting in the slip for over a month with no slime visible on the waterline and no discernible growth on the hull where the new paint was applied. The mystery of the failed ACT paint will never be completely solved.

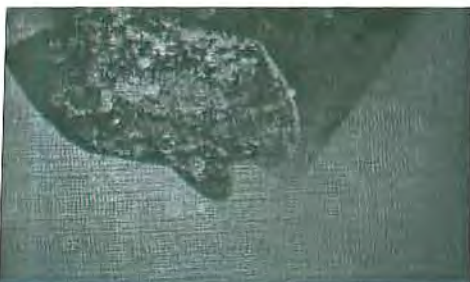
Beckoning keel after 3 weeks of not cleaning the hull in the

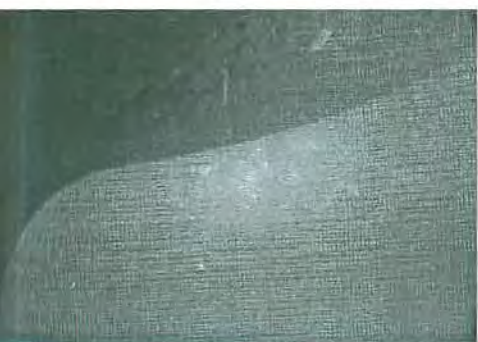
The following photo shows the hull only a week prior to loading on the Dockwise ship for transport to Newport, RI. I had spent almost 4 hours cleaning the hull prior to this photo. My scuba compressor was getting a workout!

Beckoning hull after cleaning in very late April at Jost Van Dyke

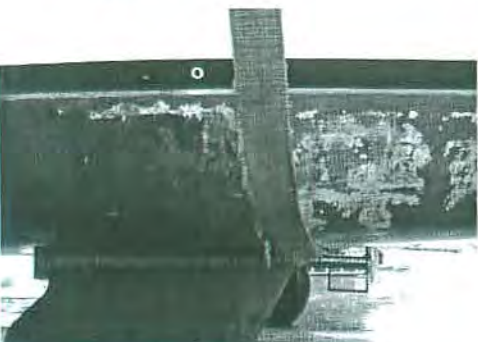
Beckoning hull half power_washed upon haul out

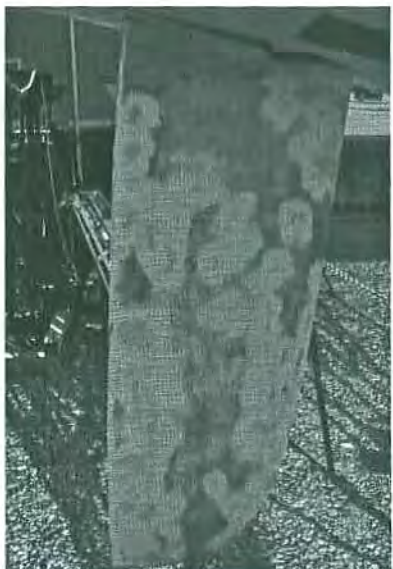
Beckoning rudder after vinylester patching (darker spots)

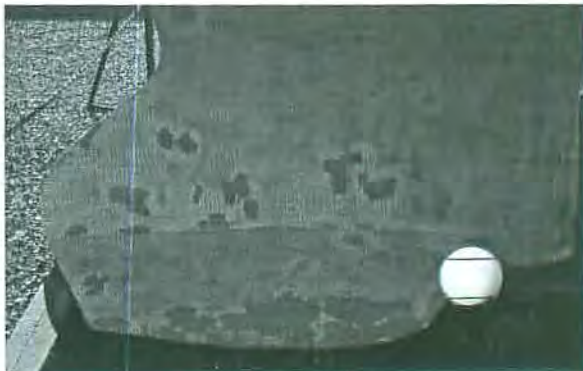
Beckoning keel after soda-blasting damage and initial vinylester repair
