# Tech Notes

## CATALINA 470 NATIONAL ASSOCIATION

### C470 Compression Post Access Hole

C470 Association  
Technical Editor  
Joe Rocchio

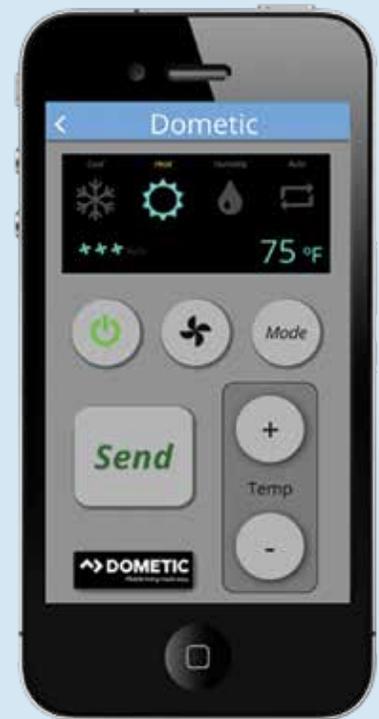
The Dometic sensor will allow you to remotely turn on/off and control a Dometic air conditioner or reverse cycle heater.
