# Technical Pull-Out

## Catalina 470

## Catalina// MAINSHEET MAGAZINE SUPPLEMENT

### Stern Rail Outboard Engine Mount Addition

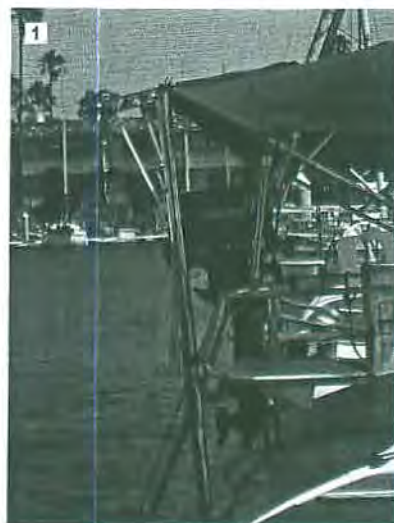
I had my outboard mounted on top of the stern rail because that made it easy to get to. I wanted a stable platform for the crane, so I also purchased a mounting plate, which was designed to match the angle of the transom on our boats. I taped the crane and mount in place, and right away I observed a couple problems.

The first thing I noticed was the crane was too tall to swing under our custom made bimini. We had our bimini made to

stick out past the stern rail, so a person can sit in the stern rail seats and enjoy a cocktail without sitting in the hot sun.

Since the bimini sticks out so far, I figured I'd have to cut about six inches or so off the crane. The problem with cutting the crane shorter is that it would put the attachment hook right on top of the engine, with no room to spare (lifting line two blocked).
