# Tech Notes

CATALINA 470 NATIONAL ASSOCIATION

## Raw Water Cooling System Issues

### Life After Solar

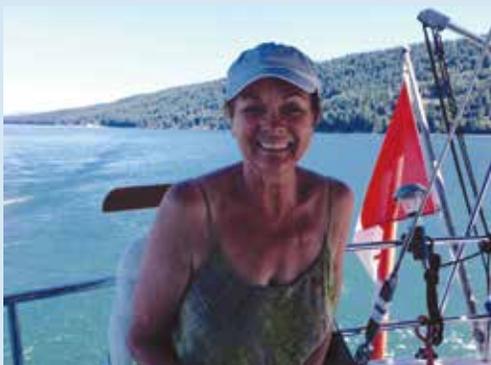
Luckily, I attended the Catalina Rendezvous that year at Thetis Island and after networking the participants I introduced myself to an owner who was importing semi-flexible panels at a fraction of the previously quoted prices. I calculated my boat's requirement with an online chart. The panels can be clasped on or with Velcro, sewn to the existing canvass. This saved an

arch installation. I think the panels do not detract from the boat's appearance and become virtually invisible.
